Machinery Messages

Case history

Transient Data Manager® 2 plots identify steam turbine generator problems

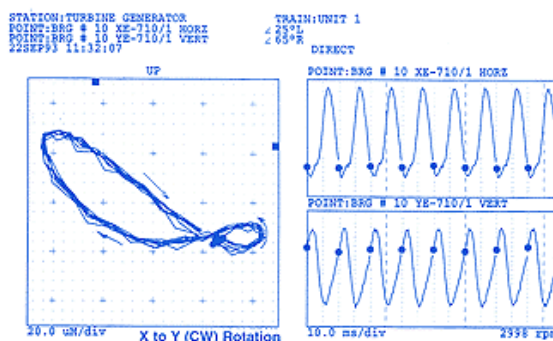
Upon startup, following a minor overhaul, TDM2 data plots immediately highlighted a vibration problem at the Exciter Outboard No.10 bearing, where a maximum vibration amplitude of over $380 \mu\text{m}$ (15 mils) pp was measured by the installed proximity transducers. The shape of the unfiltered Orbit shown in Figure 2 indicated that the high vibration was caused by a heavy downward load, such as can be caused by severe misalignment. This was corroborated by the fact that the Exciter No.10 bearing was already known to be misaligned high.

Figure 2
Unfiltered orbit/timebase plot, showing high vibration caused by a heavy downward load.

The TDM2 System immediately proved beneficial. As there wasn't time to realign the machine to reduce the load on the bearing, Laborelec and NIGEN's engineers used the TDM2 data to balance the exciter in situ to decrease the vibration levels as much as possible by eliminating the effects of unbalance. This was the most cost-effective option, due to the strict time constraints and cannot be regarded as a routine balancing job. The decision was based on the diagnosis of an intermittent rotor rub near the No. 9 bearing.

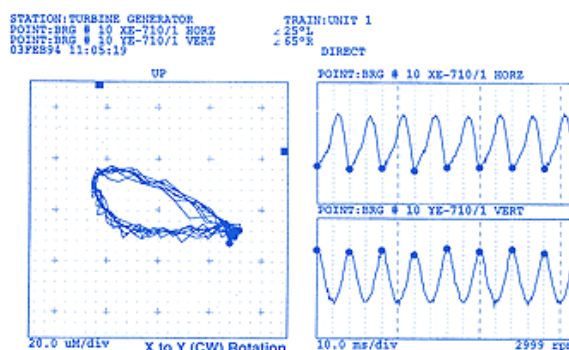
In February 1994, changes were noted in the No.10 bearing vibration behavior, following a 34-hour shutdown. Figure 3 shows that the highest measured vibration amplitude had decreased to $230 \mu\text{m}$ (9 mils). The orbit shape had become more normal, indicating a significant reduction in the load on the bearing. It was immediately suspected that bearing wear may have occurred. Figure 4 is a shaft centerline position trend plot covering the period of the shutdown. It shows that, following the restart, the shaft centerline position during normal running was $230 \mu\text{m}$ (9 mils) lower than the running position before the shutdown. The plot also shows that the shaft centerline moved progressively lower in the bearing during the time that the machine was shut down, as the shaft was turned slowly by the turning gear. Thus, the indication was that the bearing may have wiped when it was running on the turning gear, which improved the shaft alignment and consequently reduced the load on the bearing.

Figure 3
Unfiltered orbit/timebase plot after the restart, showing a more normal orbit shape, due to a reduction in load at the bearing.

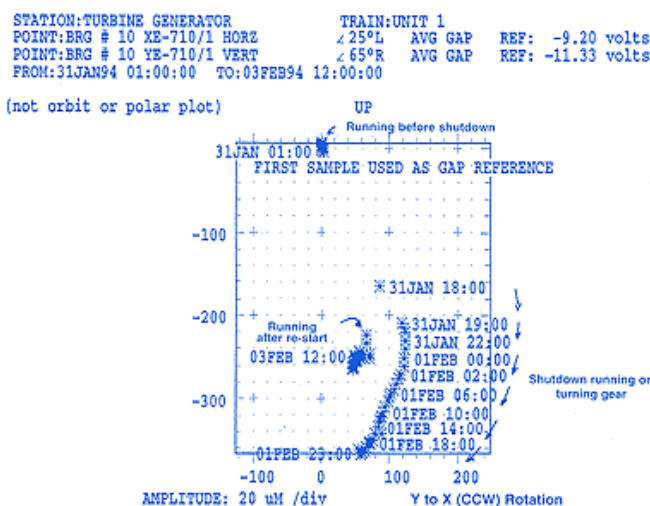
Figure 4
Average shaft centerline position plot covering the shutdown period, showing a lower running position after the restart.

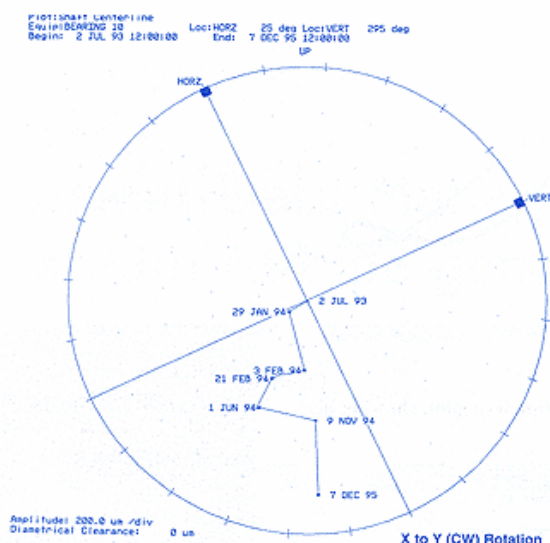
Figure 5 is a shaft centerline plot which was constructed from TDM2 trend data. It shows the running shaft

centerline position changes that occurred between load running following the overhaul in July 1993 until immediately prior to the shutdown for the next overhaul in May 1996. The movement that occurred during the shutdown (January 29 and February 3, 1994) is clearly shown on the plot.

Shaft centerline movements continued to occur. By November 9, 1994, Figure 5 shows that 515 μm (20 mils) of movement had taken place, with the vibration amplitude decreasing and the Orbit becoming less flattened (Figure 6) after the exciter holding down bolts had been tightened. The latest reading, on May 2, 1996, prior to the shutdown, indicated that a total shaft movement of 850 μm (33.5 mils) had taken place. Figure 7 shows that vibration levels had increased slightly to 220 μm (8.5 mils).

The original bearing white metal thickness was 2500 μm (~98 mils). When the bearing was checked during the 1996 overhaul, 1980 μm (78 mils) of bearing wear had occurred. Therefore, it was likely that significant wear had occurred during the balance exercise, before the initial running gap voltages were taken in 1993.

Figure 5
Shaft centerline trend plot, showing the on-going bearing wear.

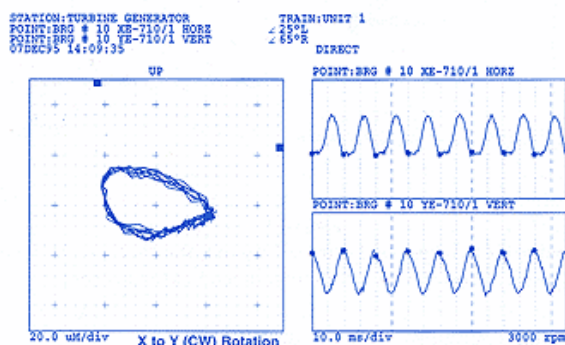
Figure 6
Orbit/timebase plot after tightening the exciter holding down bolts.

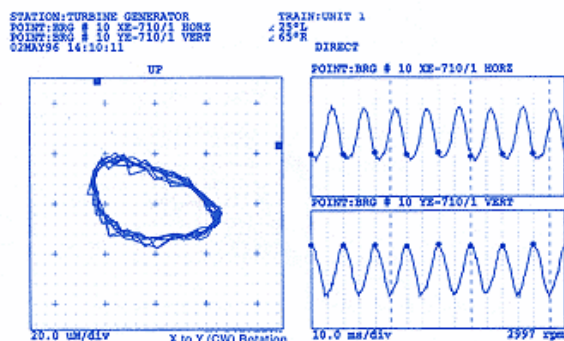
Figure 7
Orbit/timebase plot prior to the 1996 shutdown.

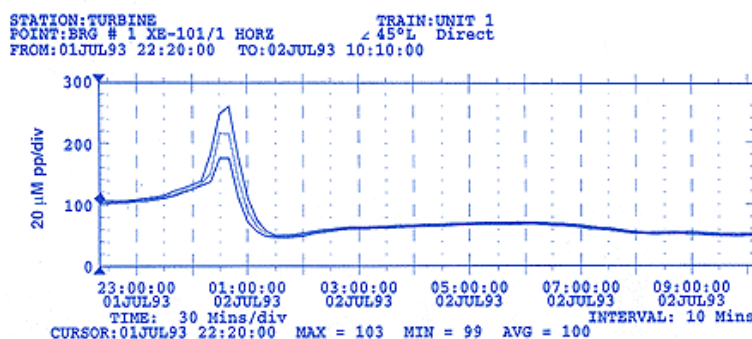
Another machine problem was also discovered by looking at TDM2 data. When the generator load was reduced or increased, subsequent vibration excursions were noticed at the No. 1 through 4 bearings. Figure 8 shows a typical vibration plot versus time. The three curves on the plot show the maximum, mean and minimum direct vibration values measured during the sample period. The variation was caused by changes in the 1X vibration vector, as can be seen from the 1X vector trend polar plot in Figure 9. The plot shows that the 1X amplitude initially increased, accompanied by an increase in phase angle, before decreasing and returning to its original value. This is one of the typical responses that can be produced by a radial rotor-to-stator rub. An explanation of the mechanism which produced the changes was published in an article, "Thermal Rub Effect in Rotating Machines" by Dr. Agnes Muszynska in the March 1993

Orbit. On this occasion, the rub cleared after one cycle of the excursion, but on other occasions the rub only cleared after several cycles. Site personnel also noted that, over a period of several months, the severity of the vibration variations progressively decreased, indicating that repetition of the rub was producing wear which would ultimately increase the radial clearance until the rub did not recur.

The load reduction was accompanied by a decrease in the reheat steam temperature to the IP (Intermediate Pressure) turbine. As the vibration excursion didn't directly coincide with the load change, but followed it, the most likely cause was the resulting temperature change, not the load change itself. Therefore, it was considered likely that elevation changes at the bearing pedestals would occur in response to the decrease in steam temperature, altering the rotor-to-stator radial clearance.

Trend plot, showing typical vibration changes over time, due to the rub.

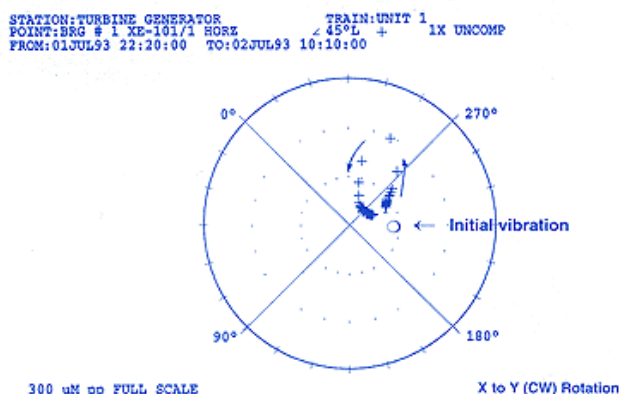
Figure 9

Acceptance Region plot, showing initial vibration (marked with an o) and vector change.

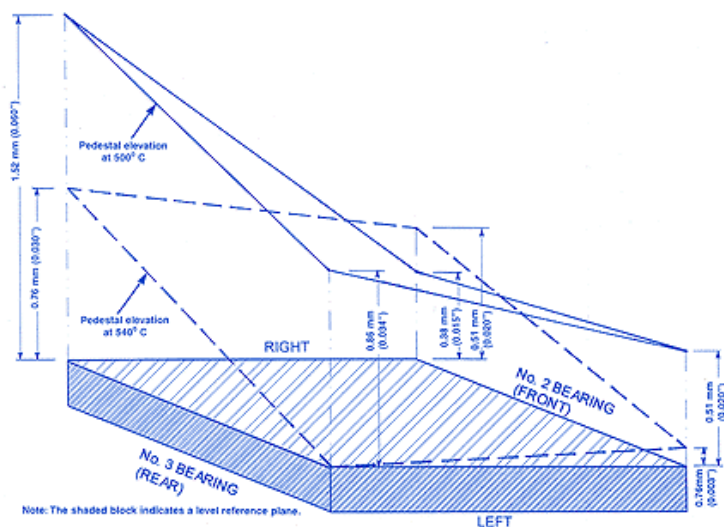
The No. 1 bearing pedestal behaved in a normal manner, with a general decrease in height as the steam temperature decreased. Figure 10 shows the relative elevations of the No. 2 and 3 bearing pedestal. The solid block on Figure 10 indicates a true horizontal plane, for reference purposes. The dashed lines show the actual pedestal half-joint elevation at full load with a 540° C (1002° F) steam temperature. The solid lines give the corresponding half-joint elevation with a steam temperature of 500° C (931° F). After the steam temperature

Pedestal thermal position study, showing relative elevations.

was reduced, the front right-hand corner of the pedestal moved down 130 μm (5 mils), as expected. However, at the other measurement positions, the pedestal rose by between 430 and 760 μm (17 to 30 mils), indicating the pedestal twisted as the steam temperature decreased.

If the pedestal movement had been a direct result of the steam temperature changes, the twist wouldn't have been expected to occur, and a general reduction in pedestal height would have been expected as the temperature decreased. Therefore, it was concluded that the twisting of the pedestal was possibly caused by pipe strain on the IP turbine casing, which was, in turn, transferred to the No.2 and 3 bearing pedestals.

A subsequent survey of the steam pipe supports did not indicate any anomalies, making it likely that the rub was caused by casing distortion. When the machine was opened up for the overhaul in May 1996, severe wear caused by a rub was found on the pedestal oil wiper adjacent to the No. 3 bearing. Rubs were also seen at the IP front steam glands and at the stage 3 and 4 diaphragms. Information obtained from the orientation of the rubs was used to modify the rotor/casing alignment during the rebuild.
